CP Logistics UK Reading Propco Limited
Theale
Reading
Mineral Resource Assessment

August 2023

Document Number:	THR-BWB-ZZ-XX-RP-CE-1003_MS
BWB Reference:	NTE2460

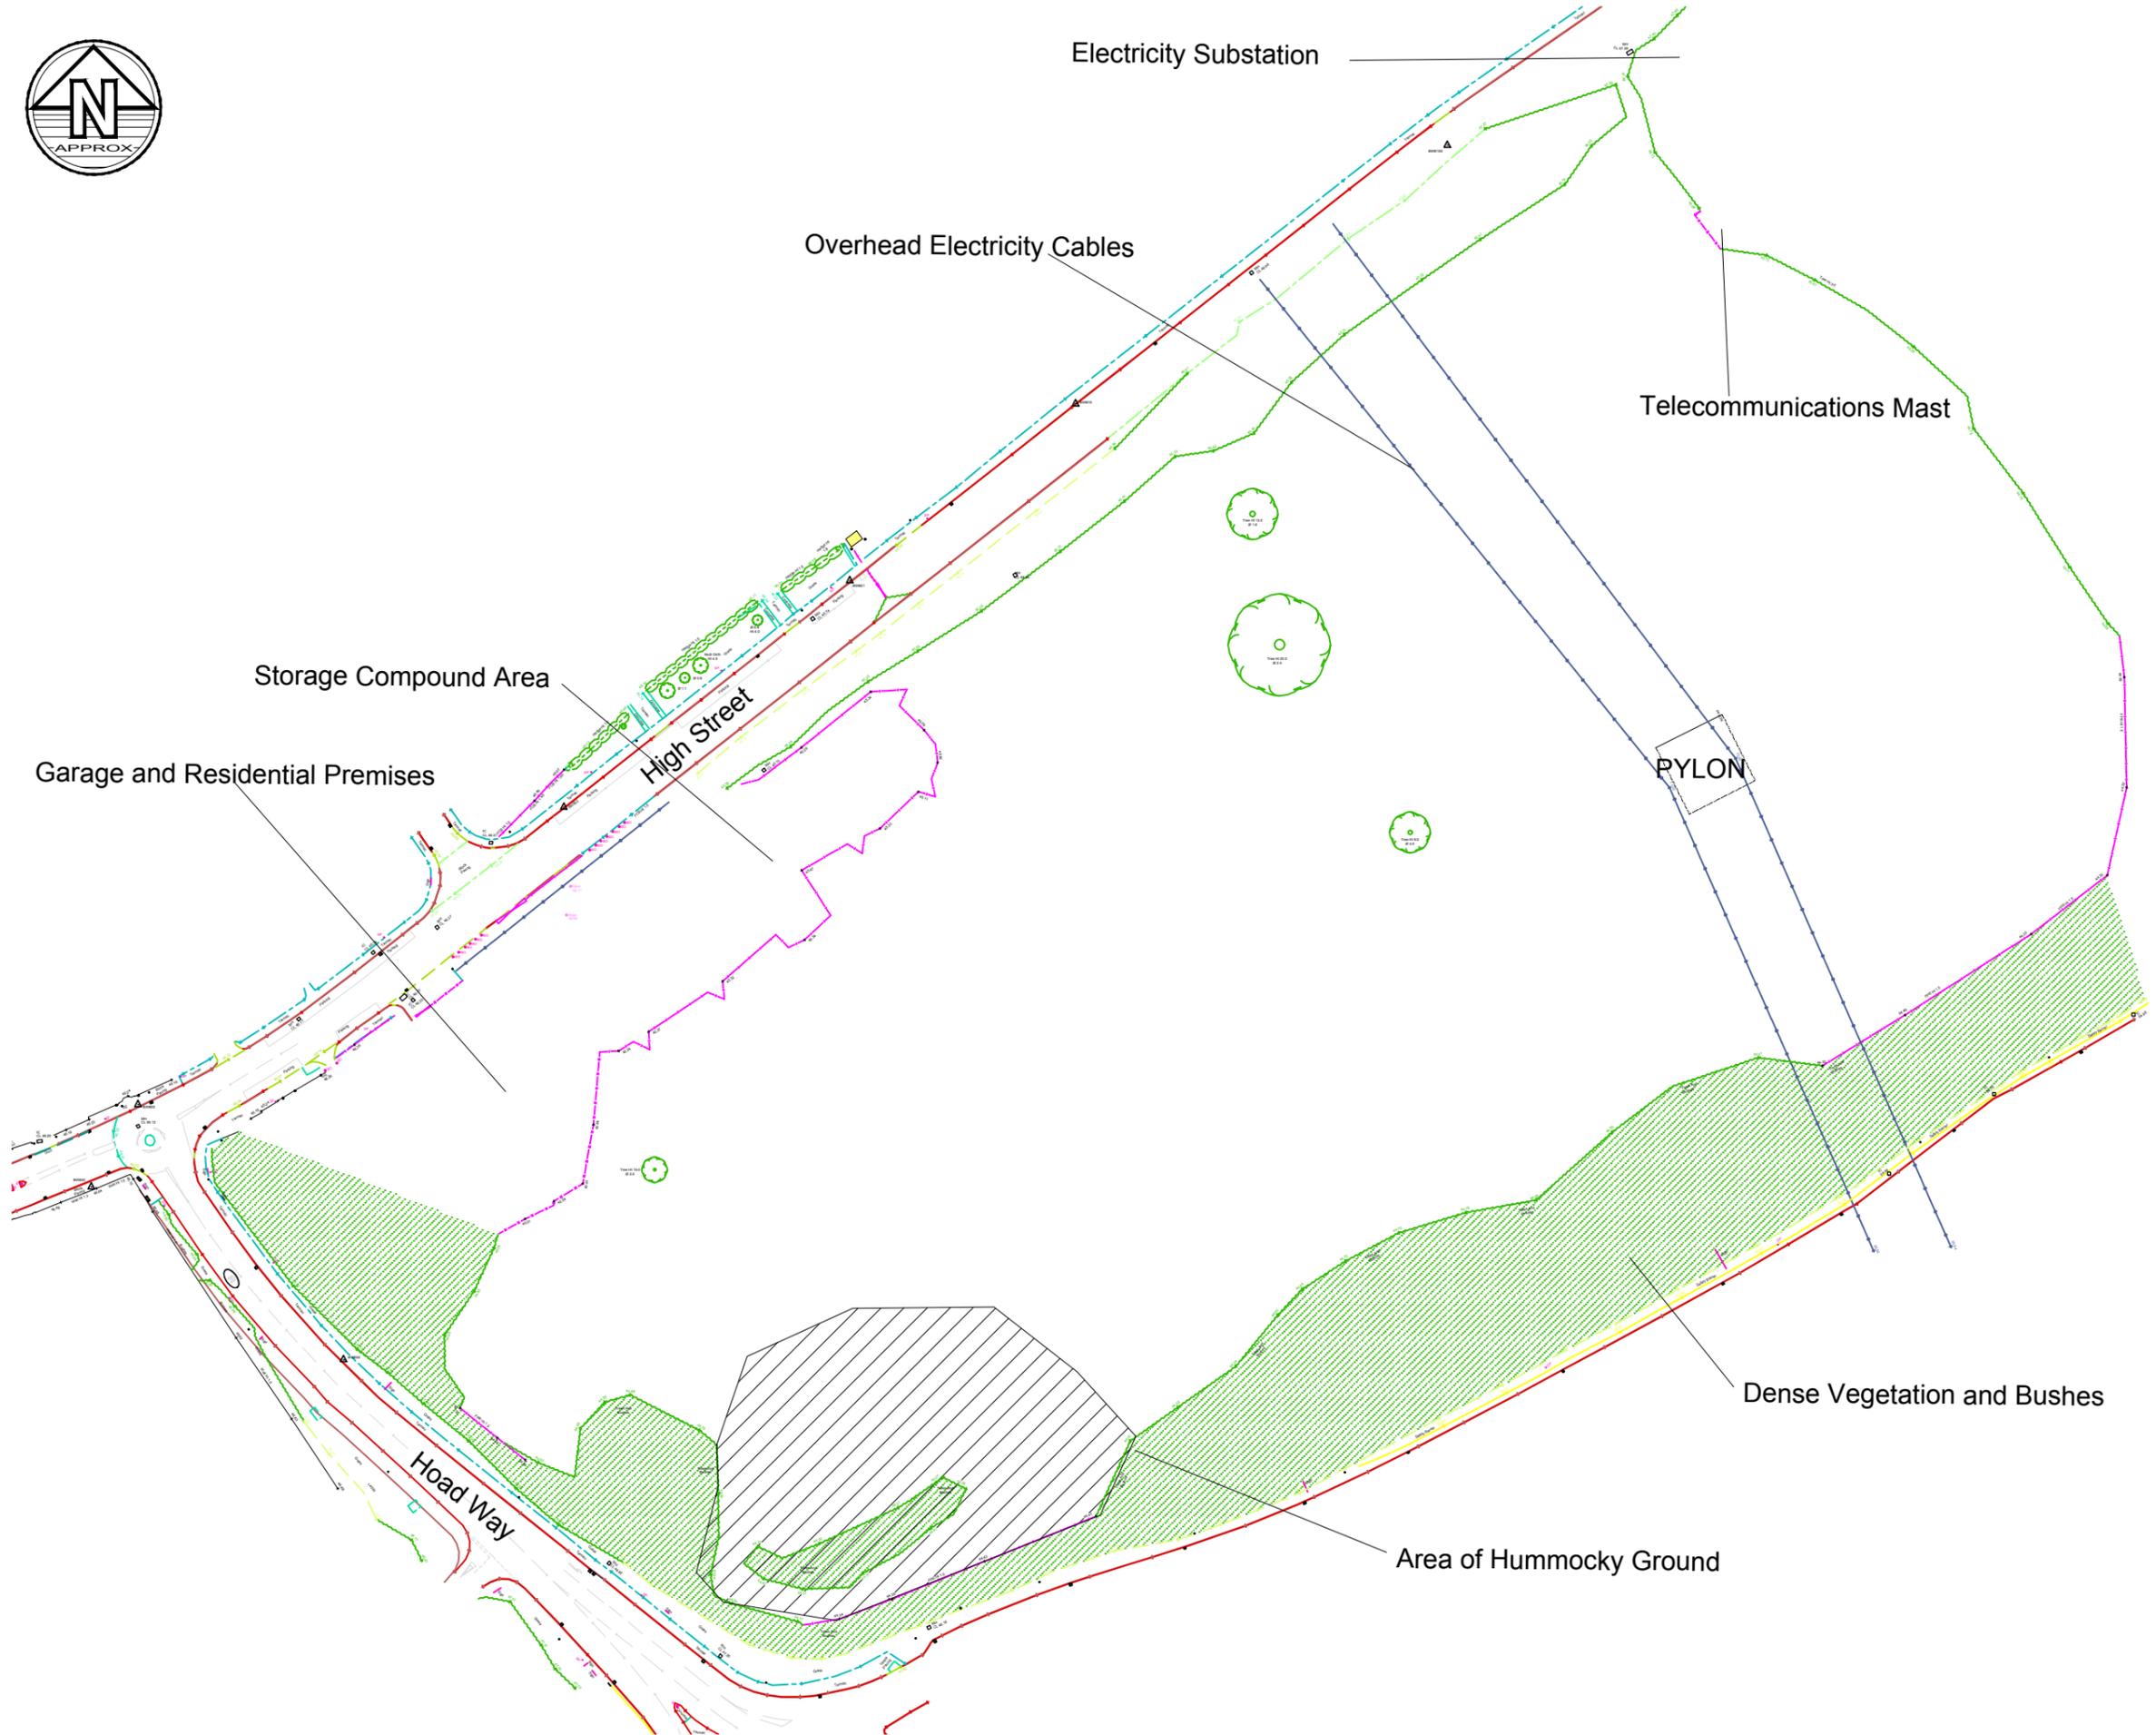
Drawing 1: Site Layout Plan

- 2.2 The layout of the site with the main features is presented as **Drawing 1**.
- 2.3 The site is a broadly rectangular shaped field covering an area of 5.5 hectares. The site is broadly flat, with minor elevation fluctuations ranging between 45m above ordinance datum (AOD) in the north west and 44m AOD in the south east.

- 2.4 The field was left to grass at the time of the walkover (September 2018) with knee-high vegetation growth. An area of hummocky vegetation was present in the south west corner of the site, deep ruts were noted in this location indicating that it was prone to being boggy. Within the southern and western boundaries, areas of dense vegetation were present. An electricity pylon is located in the east of the site.

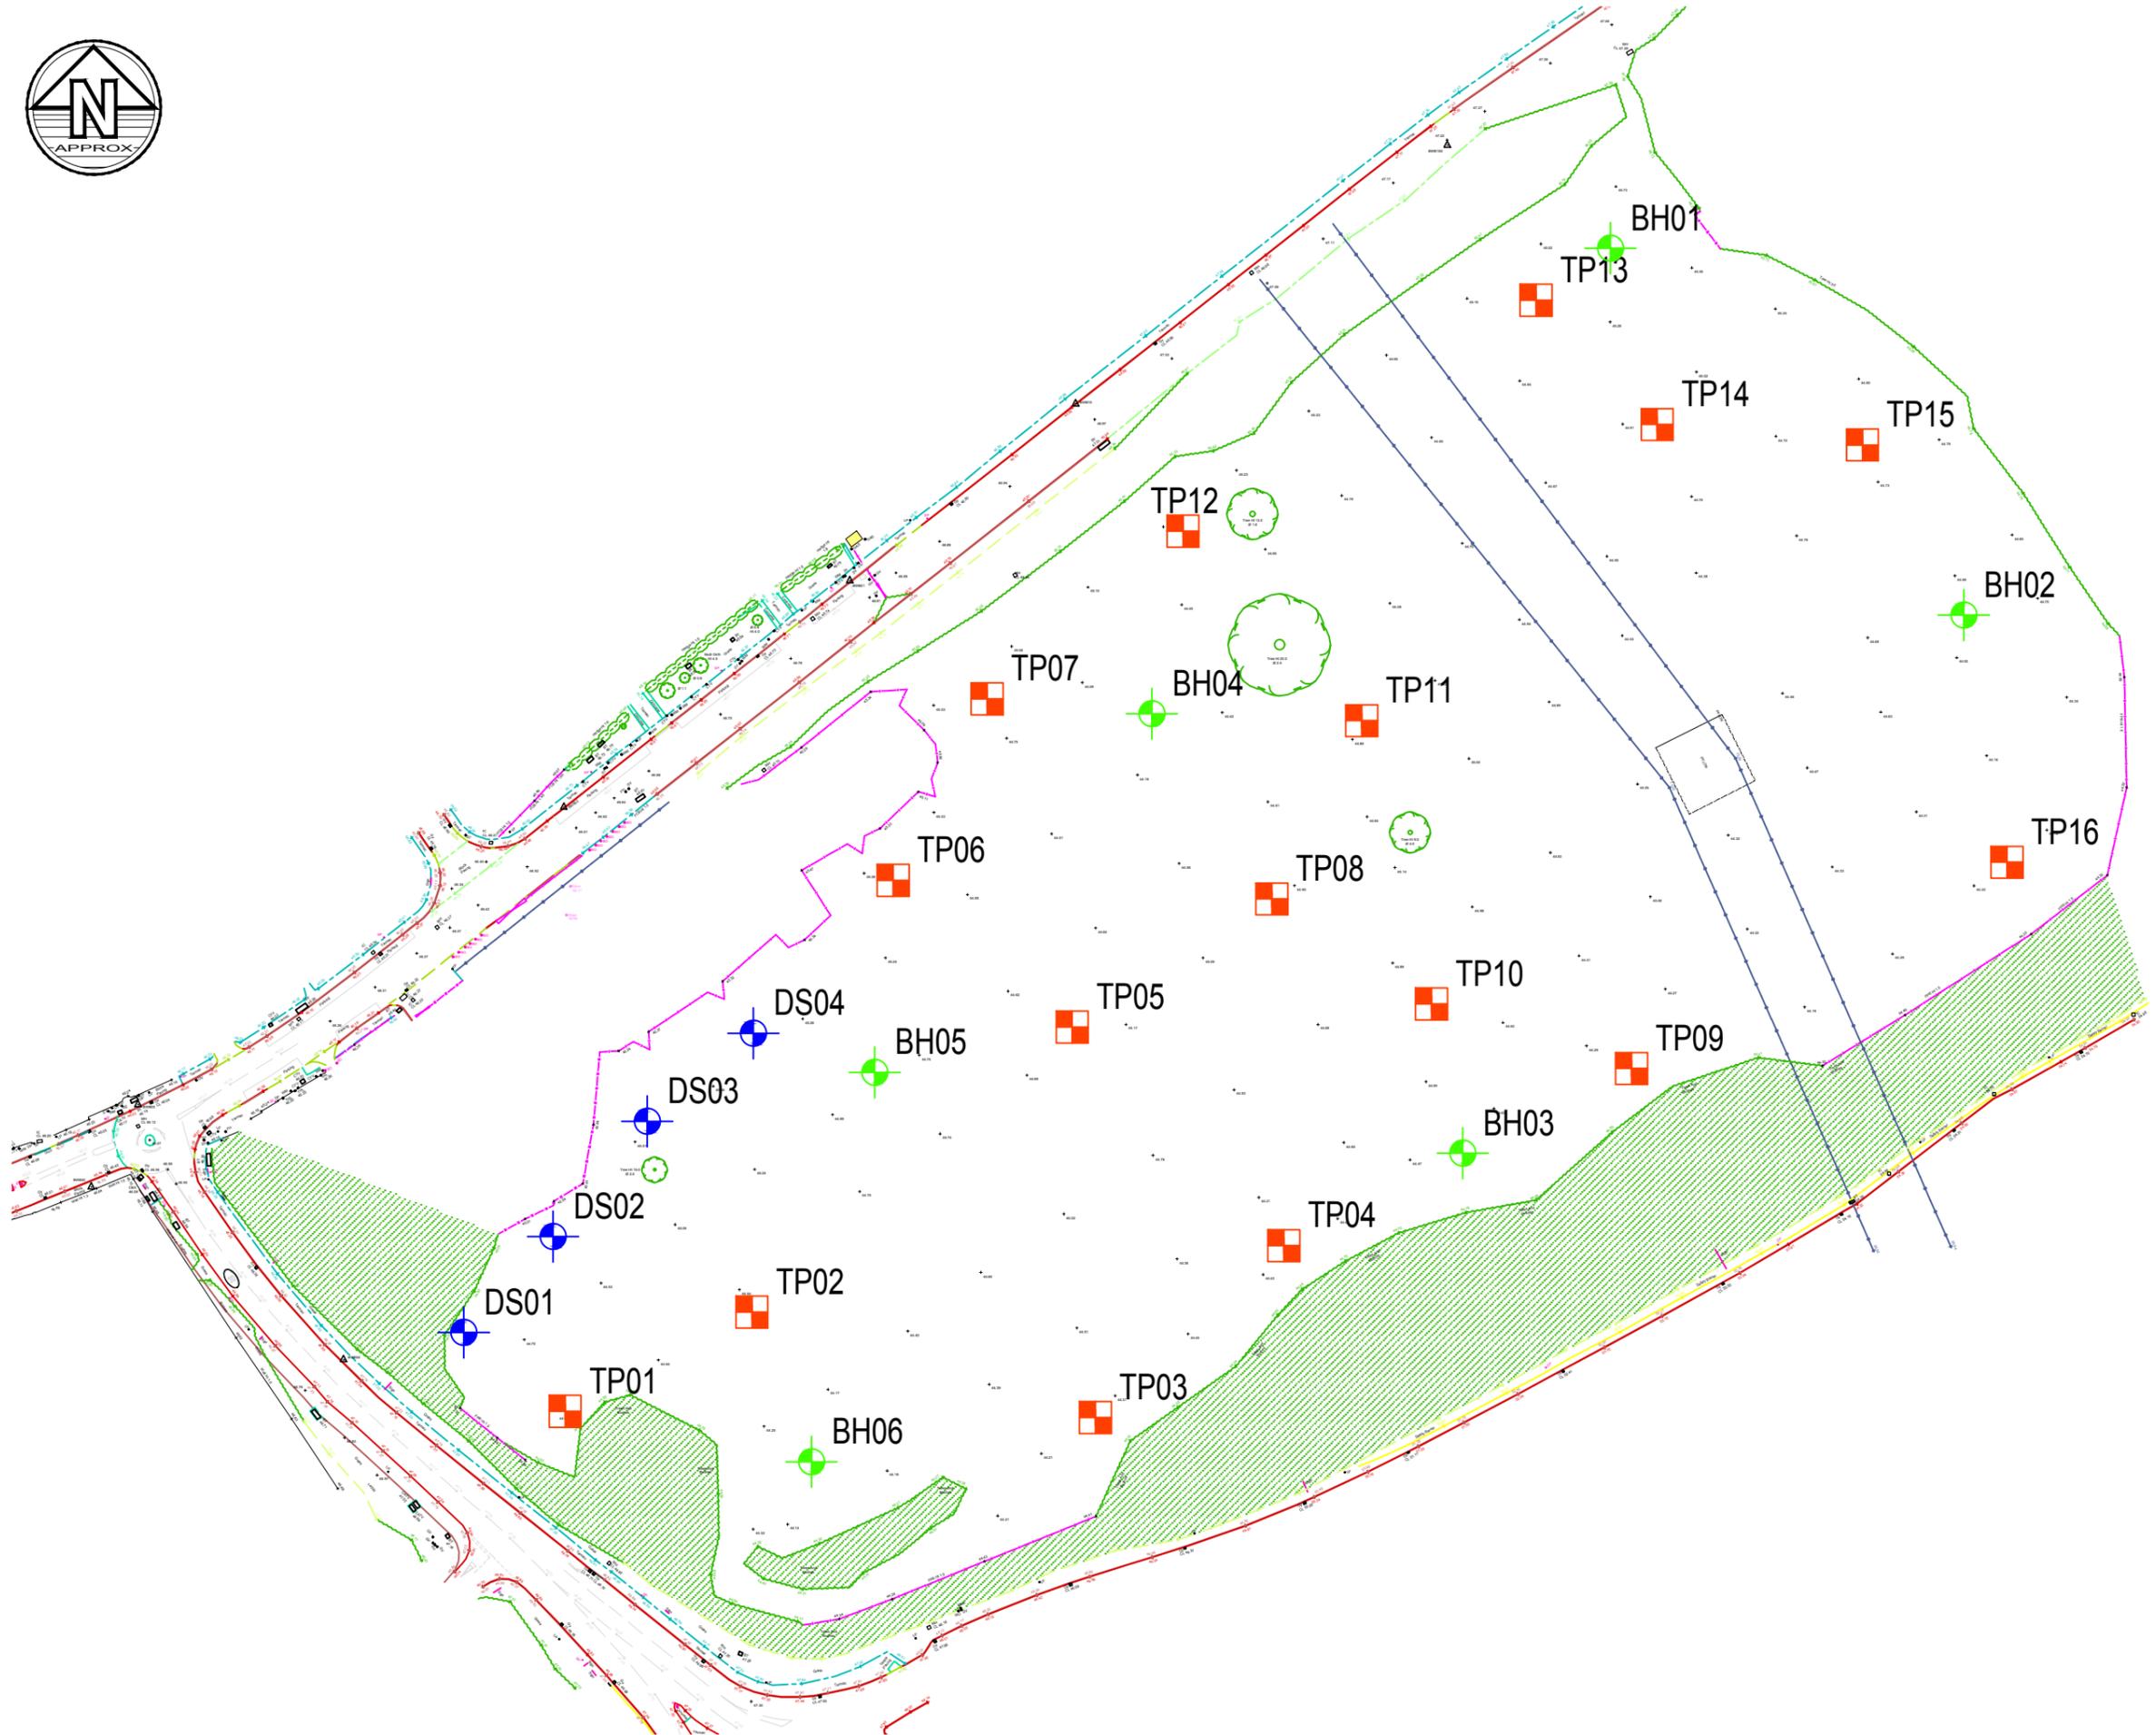
Drawing 2: Exploratory Hole Location Plan

- Legend**
- BH01 Cable percussive borehole location
 - TP01 Trial pit location
 - DS01 Dynamic sampler borehole location

- 2.12 The Phase 2 report incorporated ground investigation data acquired from 16 trial pits, 4 dynamic sampler boreholes, 6 cable percussive boreholes, 2 gas and groundwater monitoring visits and geotechnical and chemical analysis of soils. An exploratory hole location plan is presented as **Drawing 2**. Copies of the logs and gas and ground water monitoring results are presented as **Appendices 2** and **3** respectively.

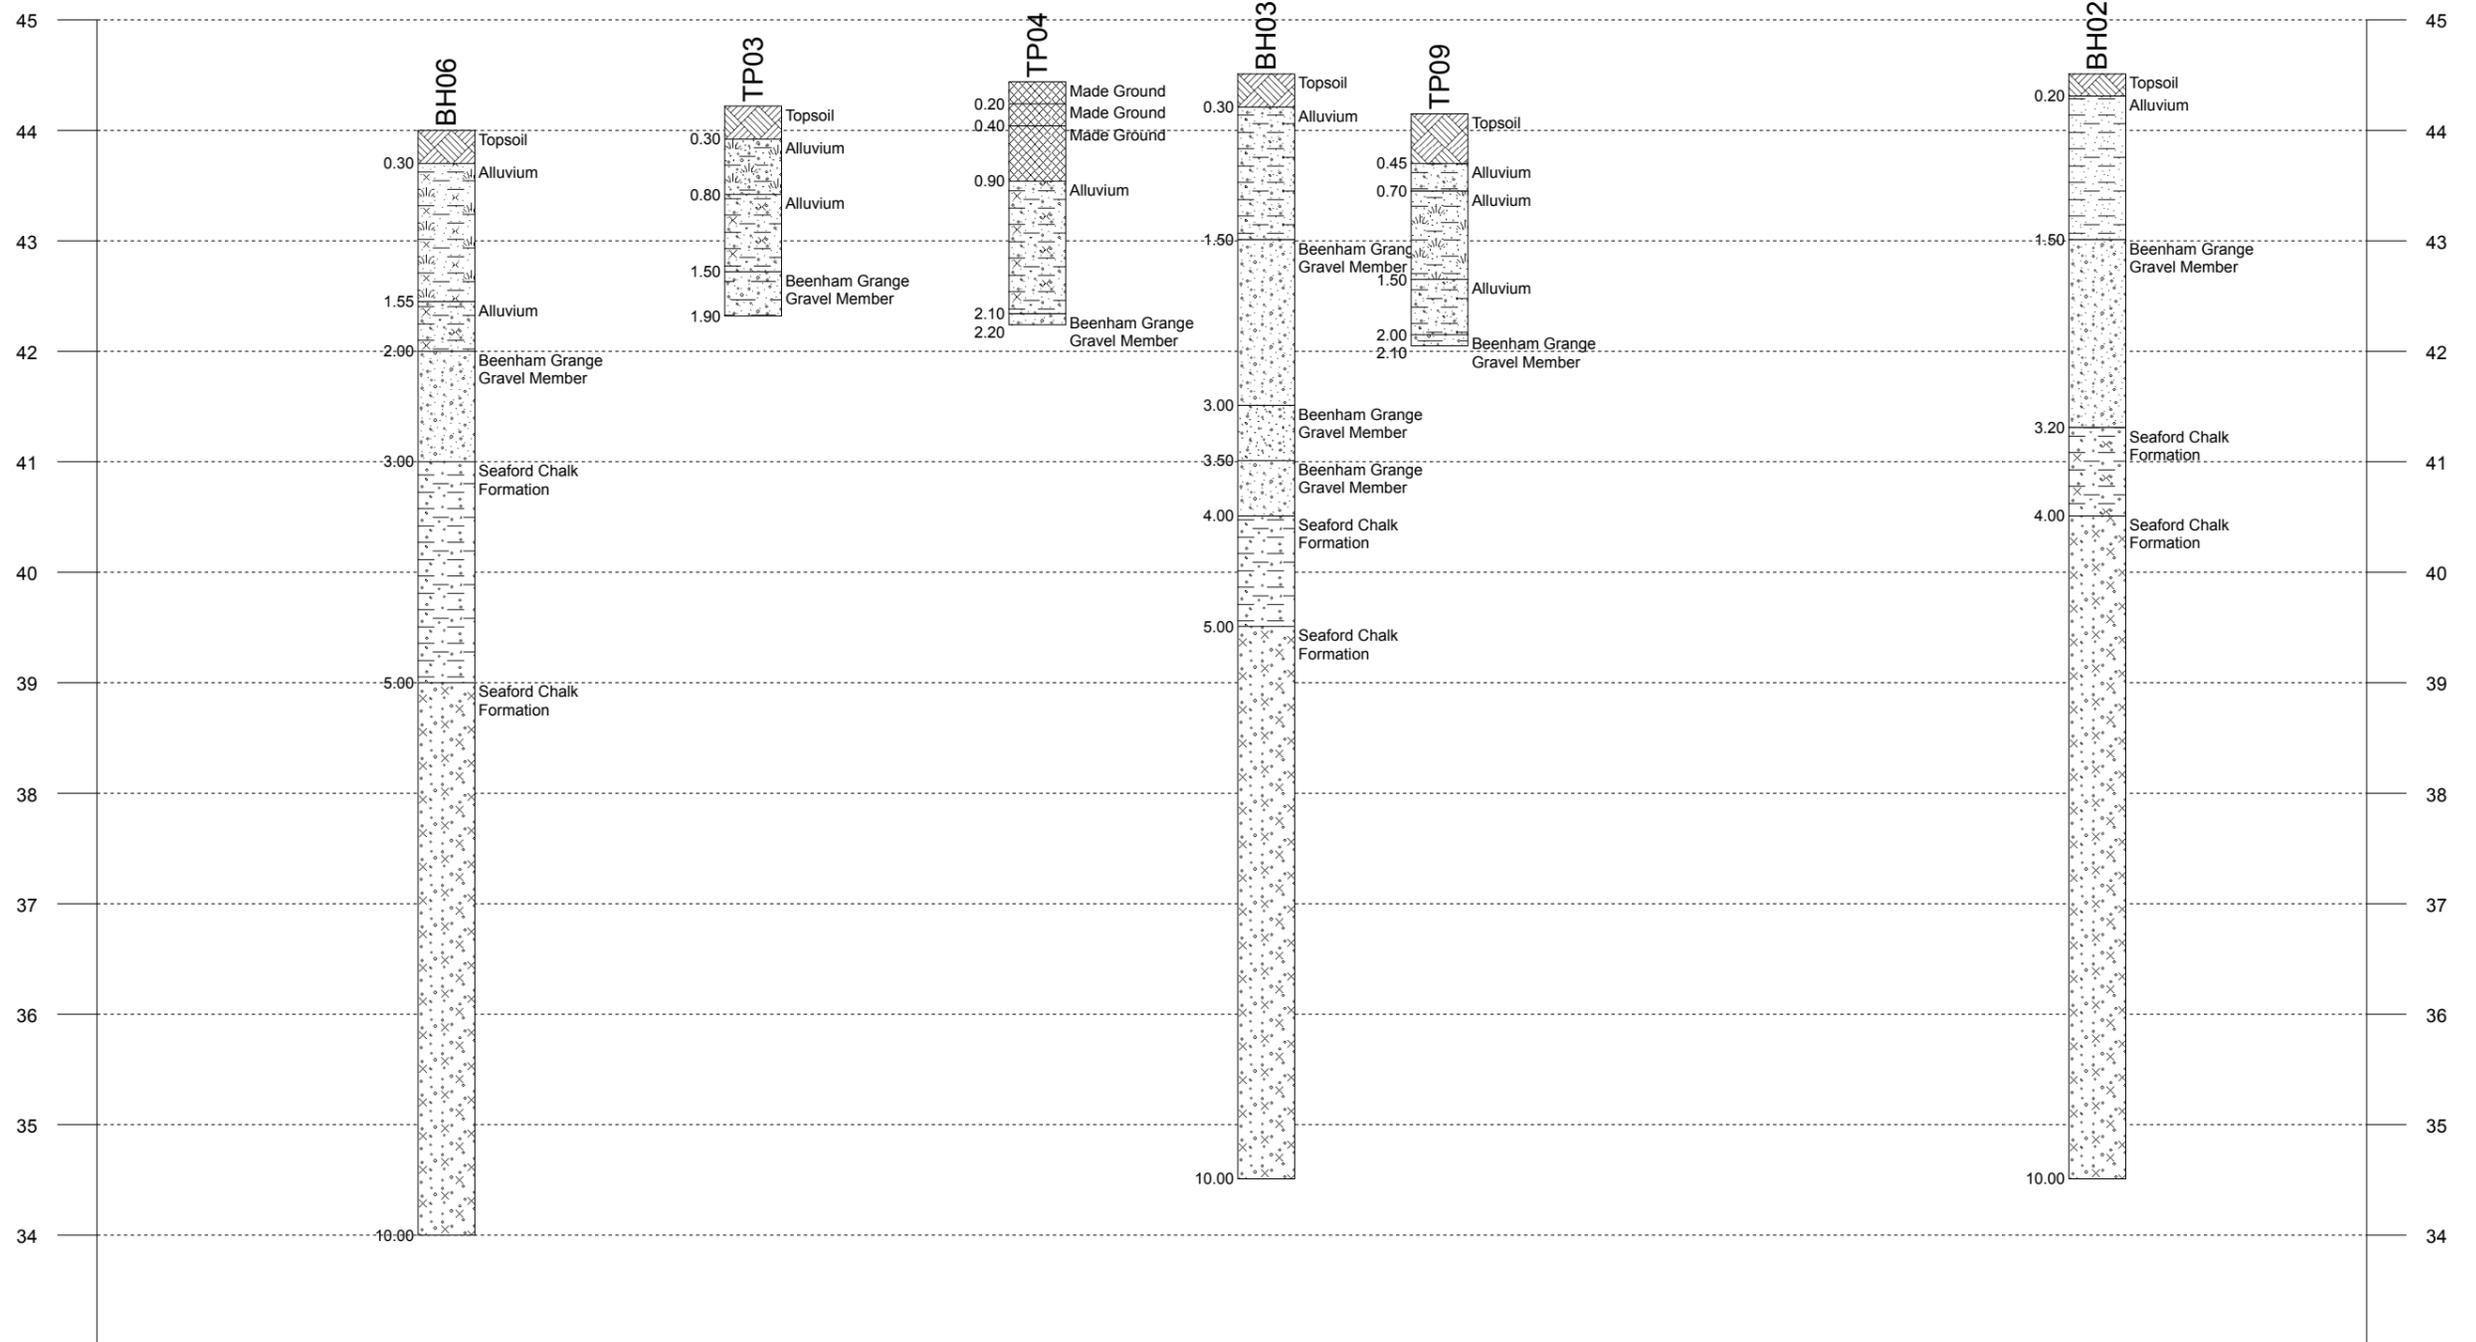
Drawing 3: Inferred Geological Cross Section

Chainage (m)	0.00	16.18	68.91	117.79	157.14	186.93	213.73	309.92	309.92
Offset (m)		3.14	18.19	11.58	10.62	12.98		8.67	
Elevation (mAOD)		44.00	44.22	44.44	44.51	44.15		44.51

- 3.3 The ground conditions recorded confirmed the published geology as discussed above, comprising Topsoil over Alluvium, over Beenham Sands and Gravels, over the Seaford Chalk Formation, with the Alluvium locally absent in the north west of the site. Limited Made Ground was encountered at the site. A cross section through the site is presented as **Drawing 3**.

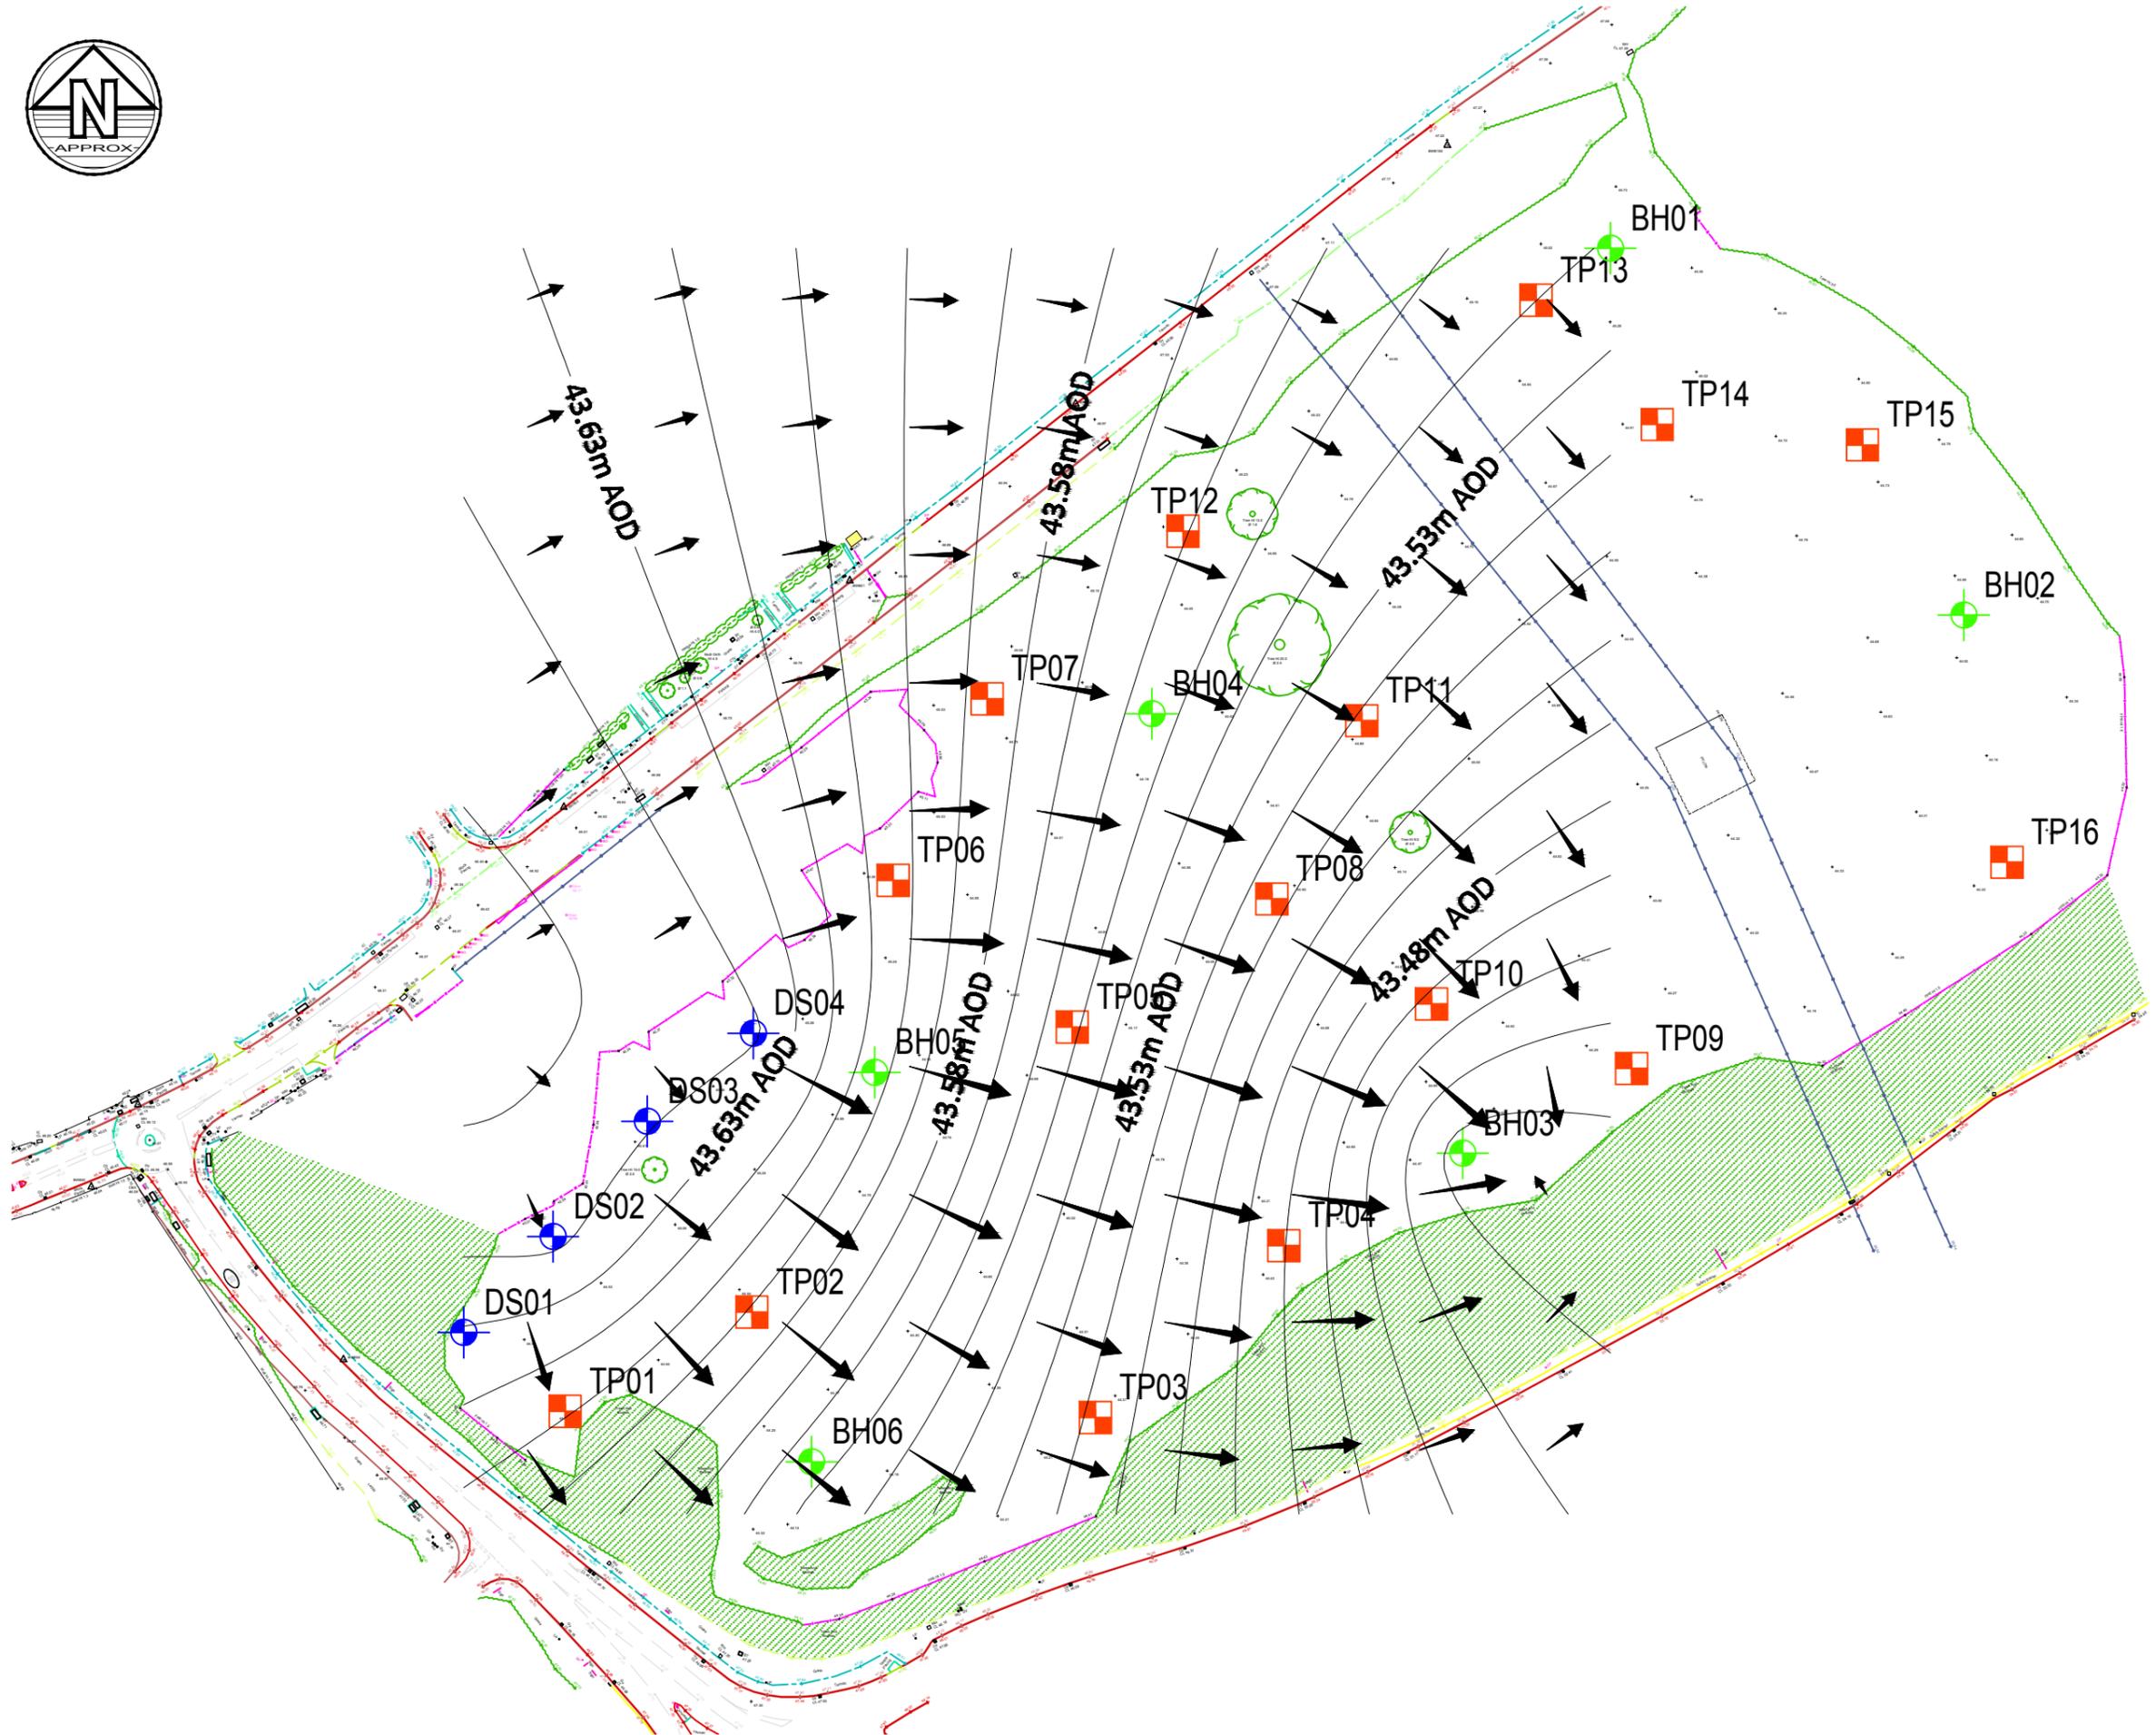
Drawing 4: Inferred Groundwater Flow Diagram

- 3.15 During the groundwater monitoring, resting groundwater levels were recorded between 0.53m bgl and 2.0m bgl, which correlates to between 43.42m and 43.64m AOD. An inferred groundwater flow diagram is presented as **Drawing 4**, indicating general groundwater flow is towards the east. The boreholes have response zones predominantly within the gravels; however, a response zone was also located within the Alluvium and chalk also. Therefore, the monitoring indicates that the groundwater bodies at the site are in hydraulic continuity with each other.

- 3.16 Groundwater levels appear quite consistent across the site, and in areas of increased Alluvium thickness, groundwater levels were noted to rise above the levels of the gravels indicating that the Alluvium is locally confining the underlying aquifer.

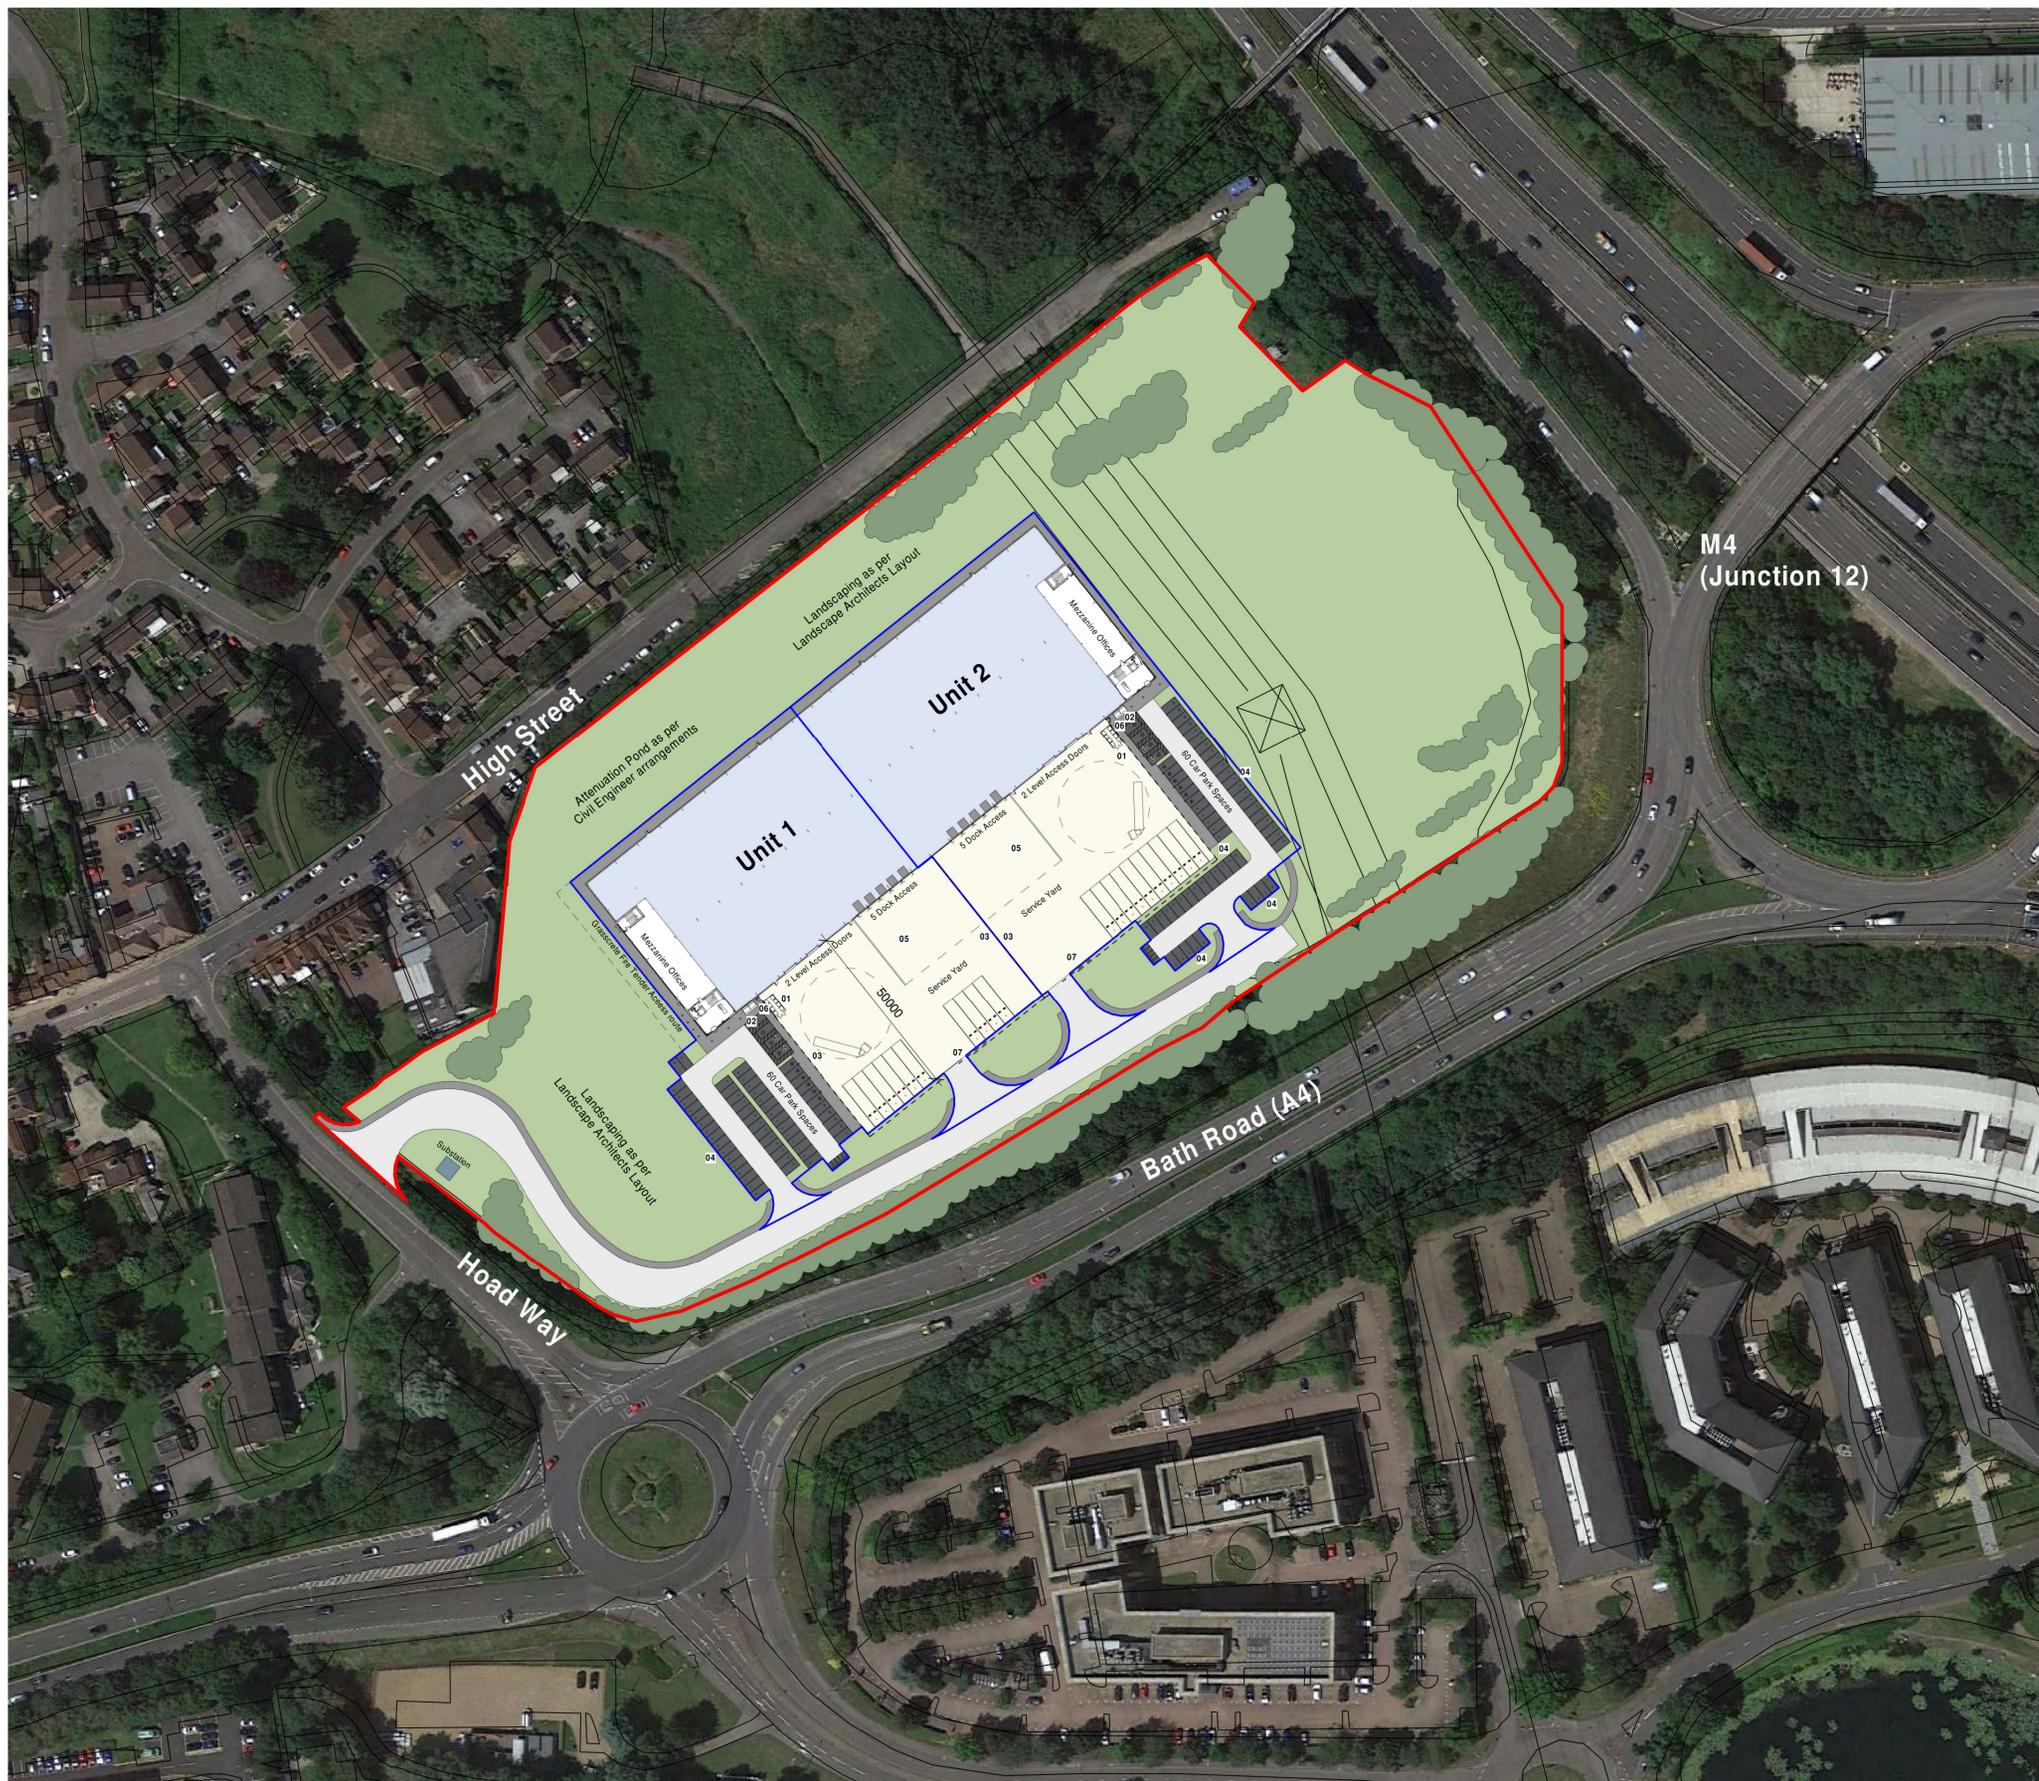
Appendix 1: Proposed Site Masterplan

01 WASTE MANAGEMENT STORE
Concrete base with 2.4m high timber palisade fencing with galvanized structure.

02 BICYCLE STORE
Urban Engineering 'Series A' or similar and approved Polycarbonate transparent sheets with polyester powder coated steel frame.
Colour: White (BS00E55) Sheffield steel cycle racks or similar and approved to accommodate 10 cycles per shelter.

06-07 VEHICLE AND PEDESTRIAN GATES:
To security sensitive areas near the main access road, vehicle gate is to be black steel paladin, 2.4m high to BS 1722-12:2006 (including concrete foundations). Gates to hinge open and be able to be held in the open position by providing bolt sleeves. Posts to be square section powder coated black steel with capped tops, cast in concrete bases.
